## **Mars Society Engineering Report**

from the Mars Desert Research Station (MDRS)

Report By: Joseph Palaia

6/26/2017

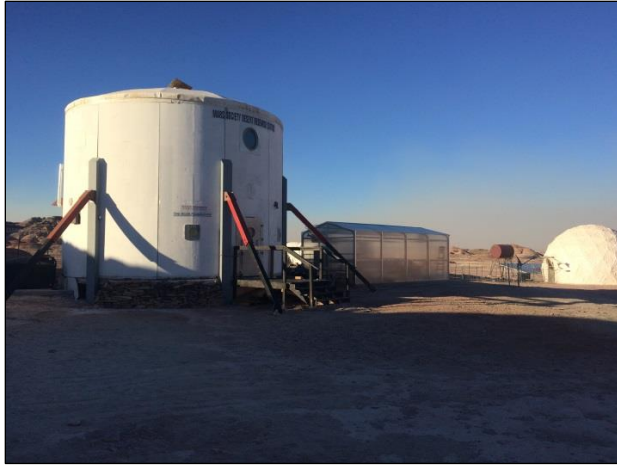
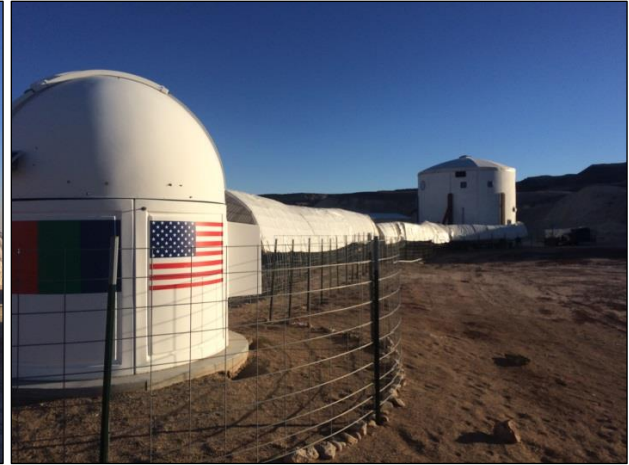
Signs greet you upon your arrival at the property, including one describing in general terms the station, its purpose, and the purpose of the Mars Society. There is also a “No Entry Please” sign to dissuade visitors from tampering with the station or interrupting simulations in progress. I would recommend that a much larger, more permanent, very professional sign be placed near the entrance to provide those curious visitors additional information as well as a request for their support of the program through donations and sponsorships.

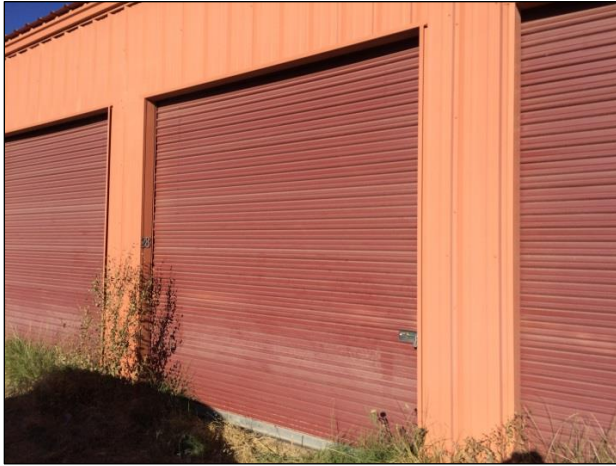
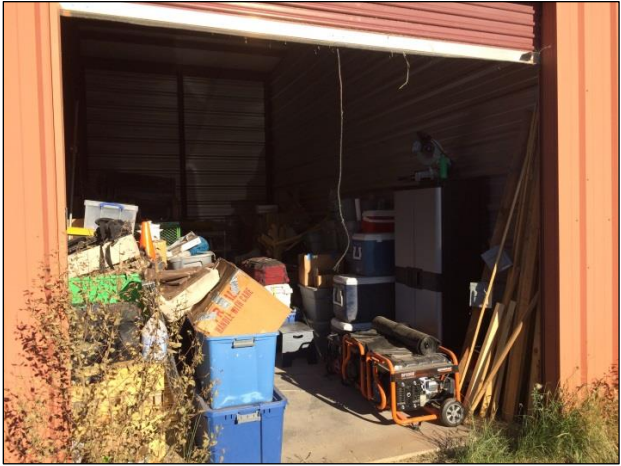
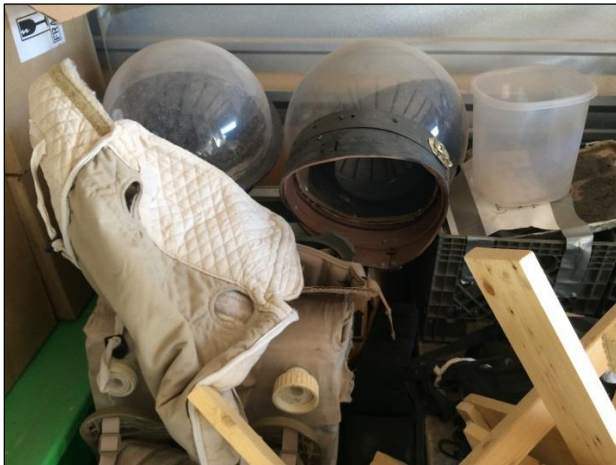
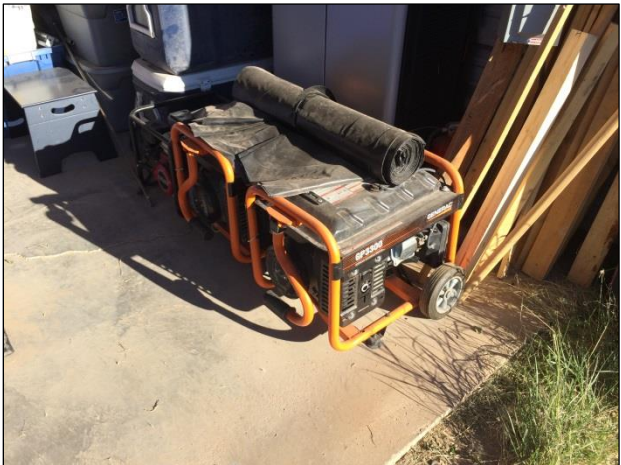
### Mars Society Storage Unit in Hanksville

Prior to returning to the site on the 24<sup>th</sup>, I visited the Mars Society's storage locker. It seems fairly organized and appears to contain surplus and support materials. This included some older space suit parts as well as three small generators.

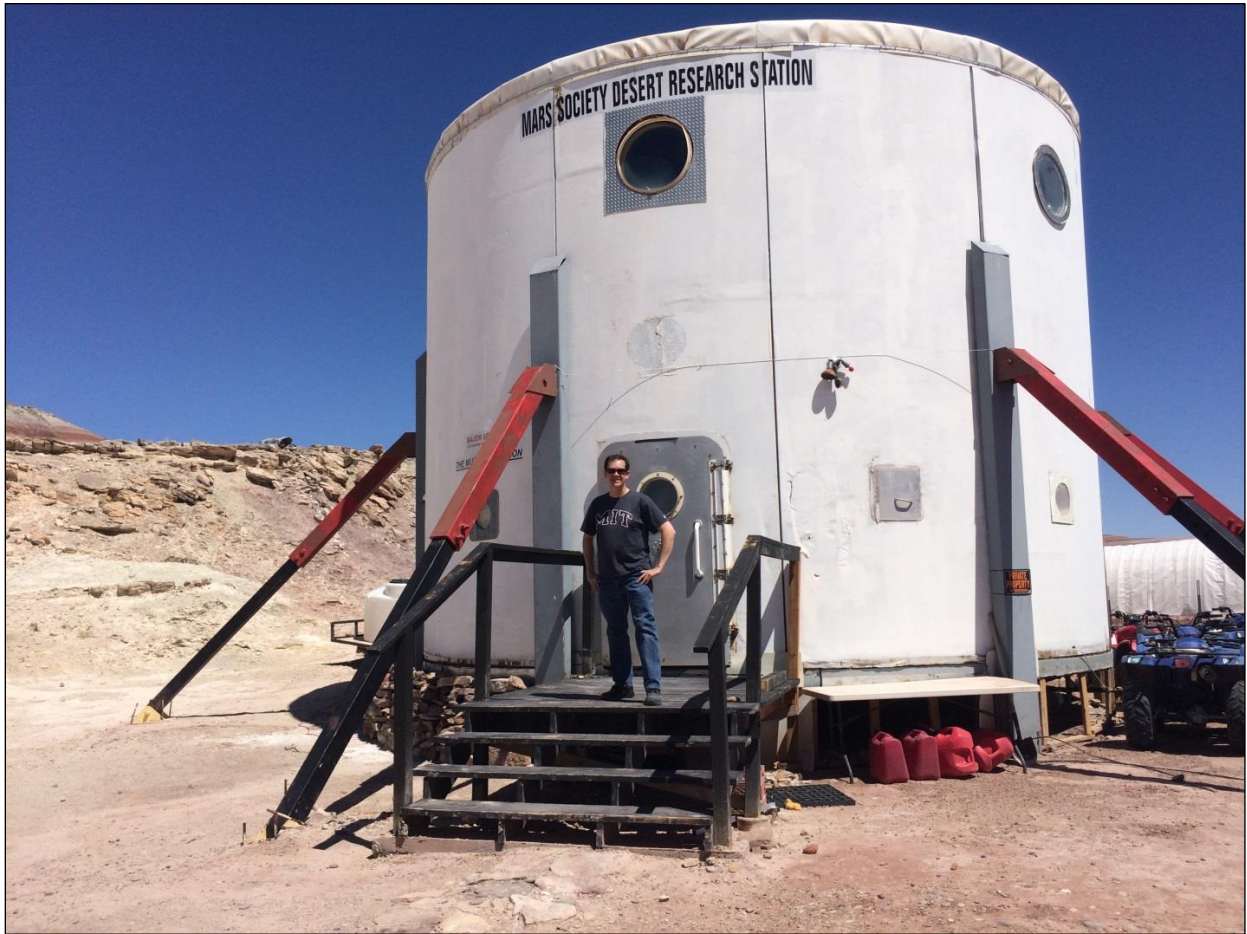
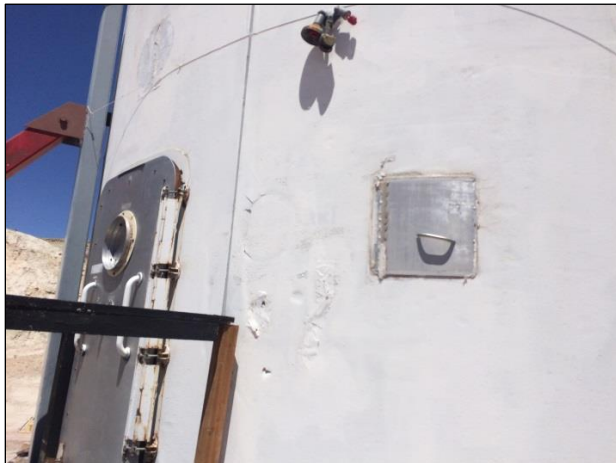
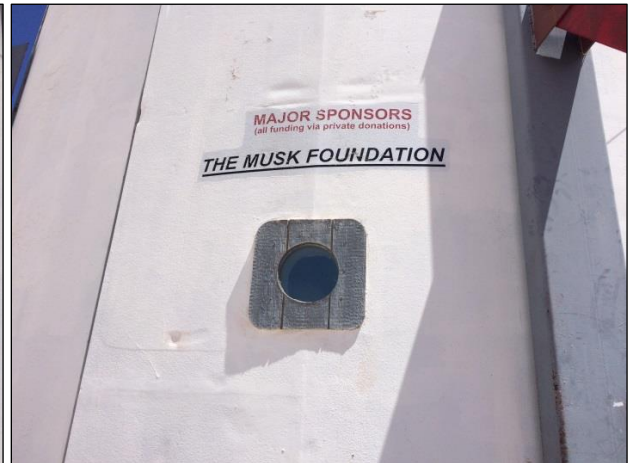
- 1) The exterior of the hab could use an aesthetic upgrade, to be performed by someone with an eye for detail. The surface is rough and uneven. It could use some sort of resurfacing and an exterior coat of paint or some other material to give it more of a high tech, refined look. Right now, it just looks old and low budget. An exterior upgrade would aid the illusion of this being a landed spacecraft, improving the psychological impact of the structure. It would also help The Mars Society to continue to attract high value donors and sponsors for whom aesthetics sometime are of significant importance. Question: What sponsor would want their logo on the side of a hab that looks old, beat up and low fidelity? On this subject, unlike FMARS, the hab is curiously devoid of names and logos, with the exception of the Musk Foundation. I would recommend an exterior upgrade first and placement of major donor and sponsor logos on the hab, using high quality decals, second. Also, I would recommend replacing the name decal at the top of the hab. Instead of “Mars Society Desert Research Station” which does not match the acronym “MDRS”, I would replace this with “Mars Desert Research Station (MDRS)” and beneath that put “A project of The Mars Society” perhaps also with the website.

- 2) At several places in and around the hab, there is significant use of wood. For example, the front porch and steps, around some of the portholes, railings and support structure inside the hab, and the main steps from the first floor of the hab to the second. While wood is a high utility, cheap, readily available material here on Earth, on Mars it will be a rare and exotic material. In my opinion, the use of wood significantly detracts from the aesthetic of the station and gives it more of a “club house” feel as opposed to a “spaceship”.

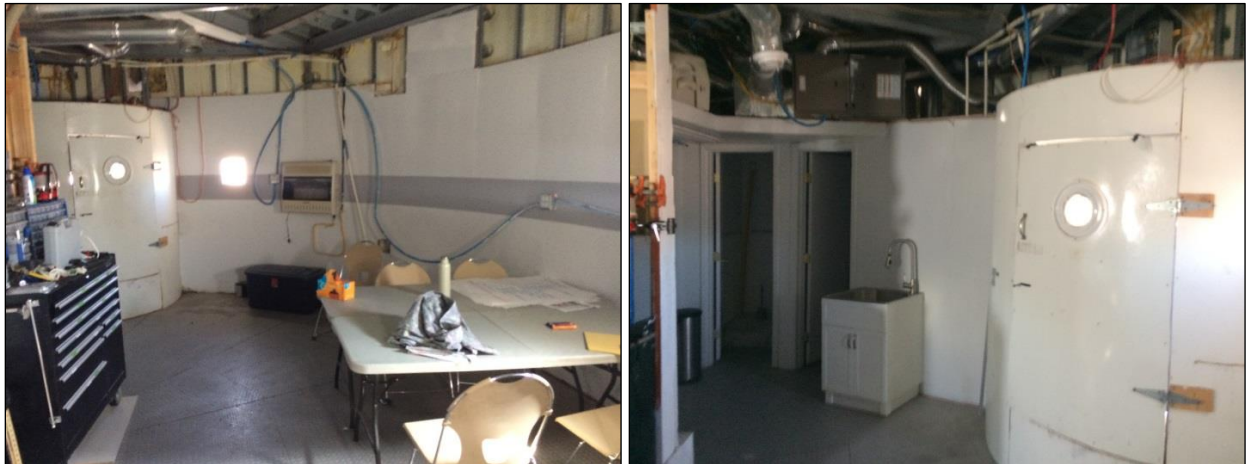
Entering into the hab proper, you are greeted by spacesuit backpacks and helmets. Everything is neat and organized. The helmets are a little bit on the tired side, with significant scratches in the transparent domes. I recommend The Mars Society task someone with finding an alternative dome material which

will not scratch and scuff as easily as these polycarbonate ones. This could perhaps be an opportunity for collaboration with researchers, maybe at JSC. What better field testing could there be for new Mars space suit helmet materials than an MDRS field season? The other thing to consider is to have each crew member that visits the station have the option of buying their own replacement dome, or choosing instead to live with the scratched one. This approach would give crew members extra incentive to be careful with the helmets to prevent scratches.

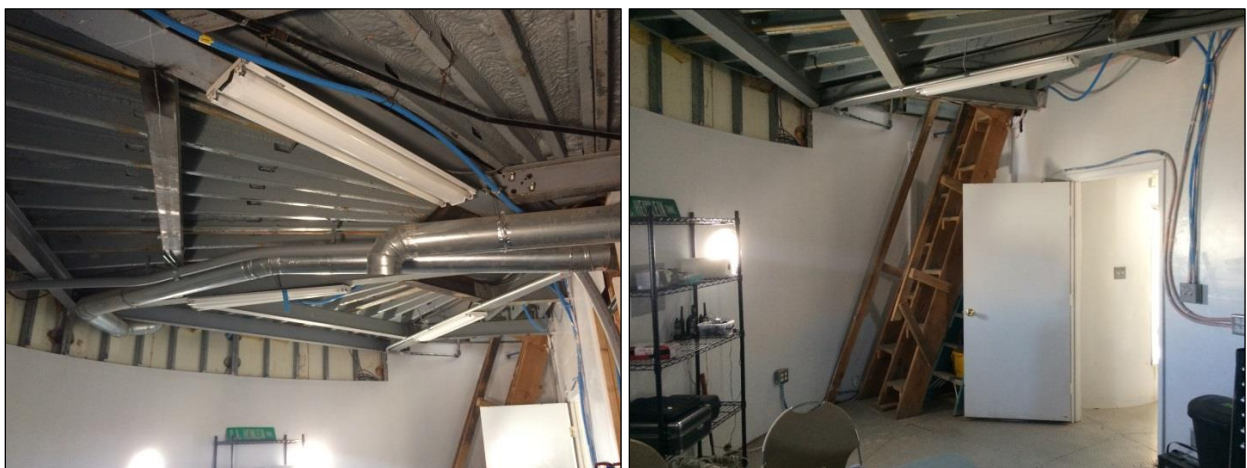
The lower deck of the hab is almost Spartan, most likely due to the fact that science lab equipment which (I believe) had been located within this area has been moved to the new Science Dome structure.

One of my biggest issues with the Mars Society's simulated habs has been nearly complete lack of emphasis on finishes, look and aesthetic. While this space is clearly of high utility, just because it needs to be utilitarian doesn't mean that it can't also look good! In the case of this space, I'm hit overhead with the thought "basement!" not "spaceship!" FMARS is not any better... this is not a complaint directed at MDRS solely. Let's just say, I can't wait to see what the team from IKEA proposes in terms of a complete refit of this floor of the hab.

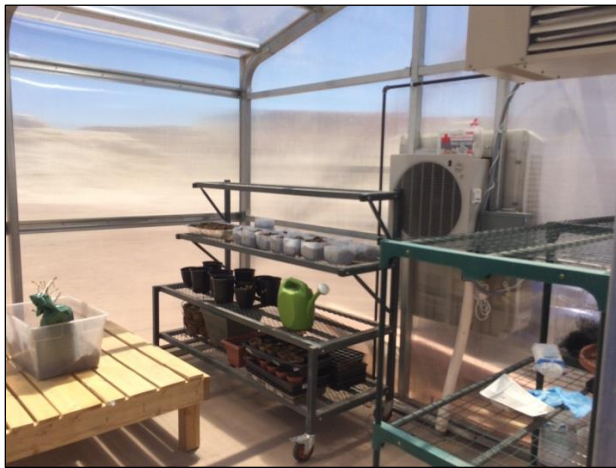
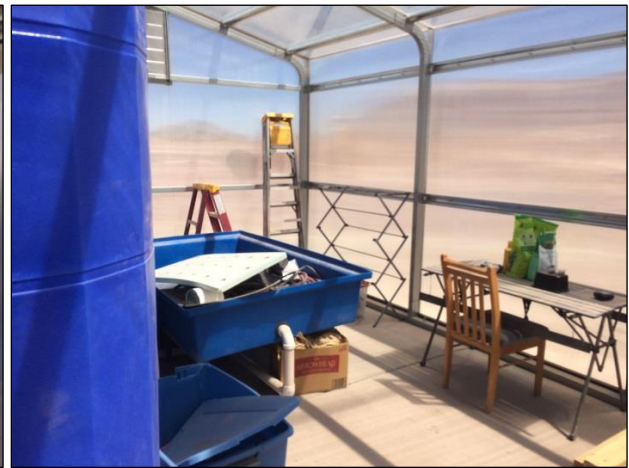
The greenhouse looks to be a solid structure of good, new construction.

There is equipment in place for air circulation and water storage. Some thought should be given to how this greenhouse is laid out internally to provide maximum growing area. An immediate thought would be to relocate the water storage tank to the exterior of the structure.

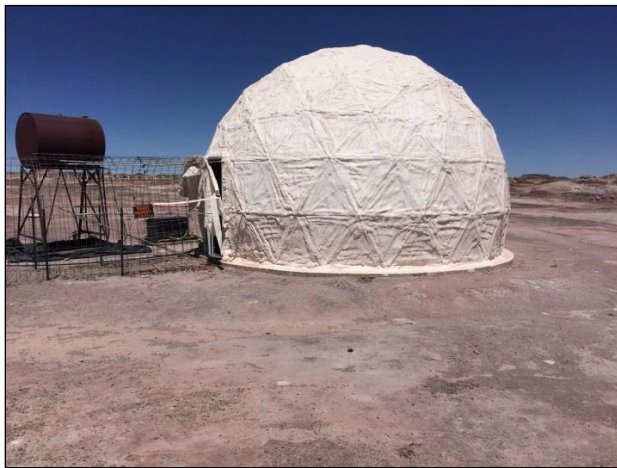
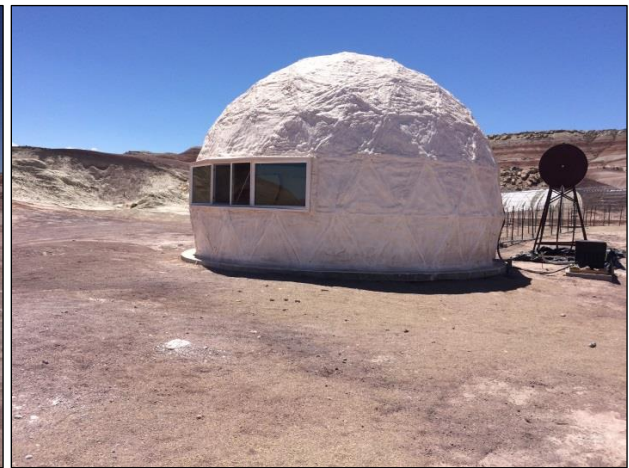
The Musk Observatory is at the end of one of the connector linkages. The exterior of the structure looks to be in good condition, however it is recommended that a high quality replacement decal be obtained to replace the faded and weathered Mars Society logo.

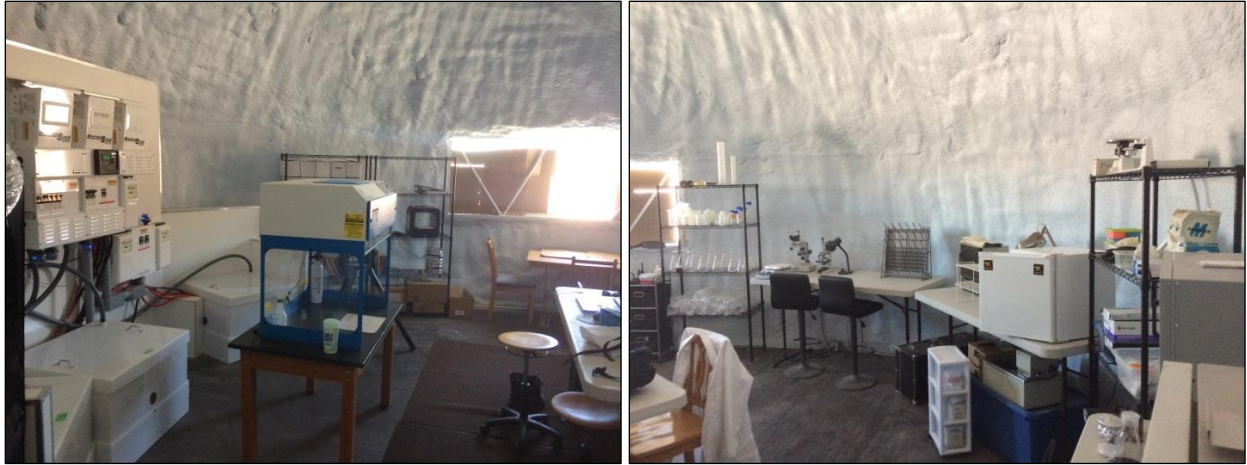
The Science Dome is the final structure on site. It appears to be very well constructed.

The Science Dome appears to be equipped with a variety of scientific instruments and supplies, and is spacious enough to accommodate additional equipment which may be added over time. It is also where the battery charge controllers and batteries are located.

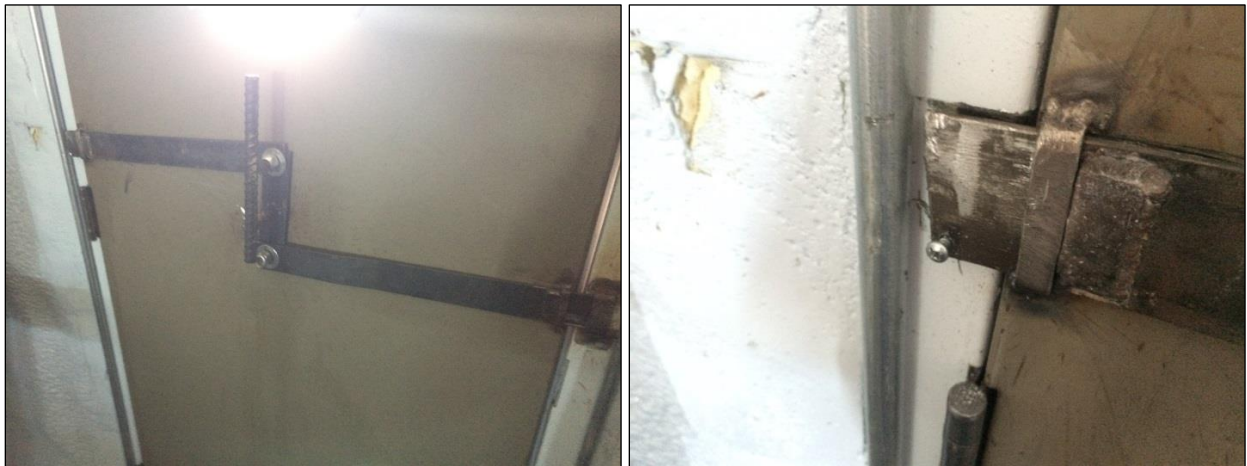
#### **Science Dome Latching Mechanism – Repair**

Upon arrival at the Science Dome, it was discovered that the latching mechanism was non-functional. This presented an issue, because without the mechanism working, there was no way to secure and close the door. This engineer troubleshooted the problem and identified that the issue was that there was no physical stop which prevented someone from turning the hatch release too far, and when it was turned too far, the metal cross members slid out of the supports at the edge of the door. This engineer realigned the cross members in their supports and installed a physical stop (a metal screw through the end of one of the metal cross members) and this has solved the problem.

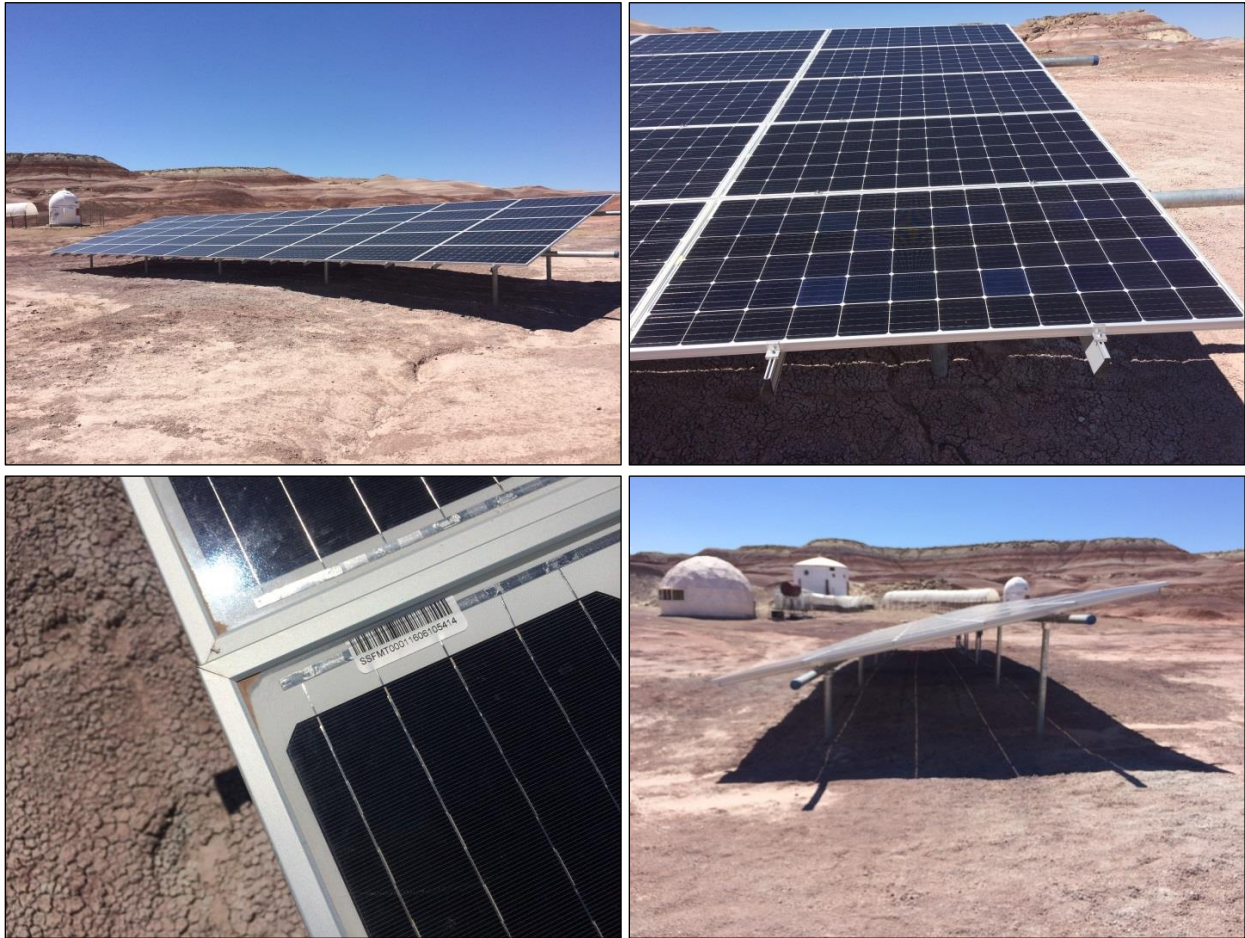
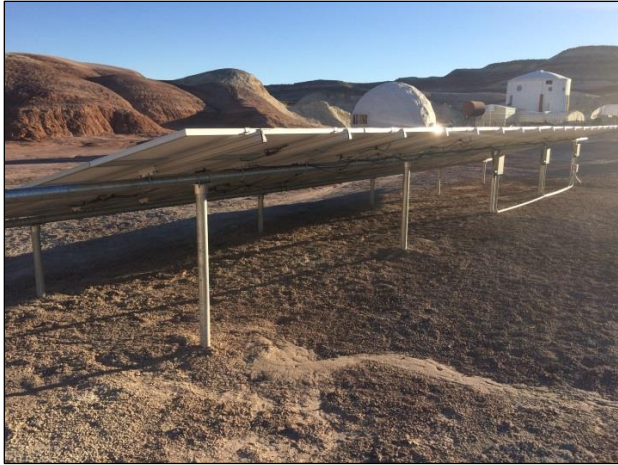
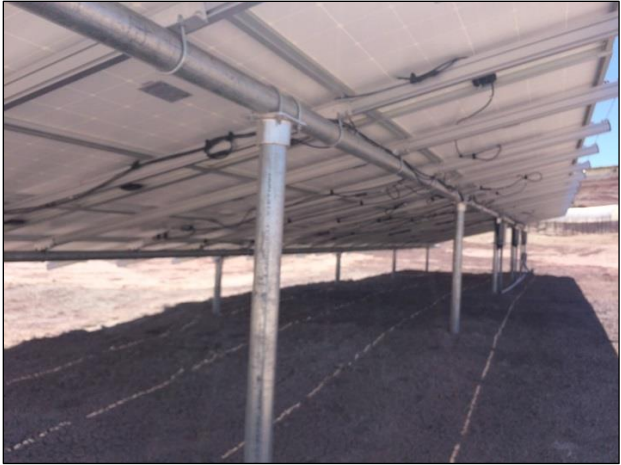
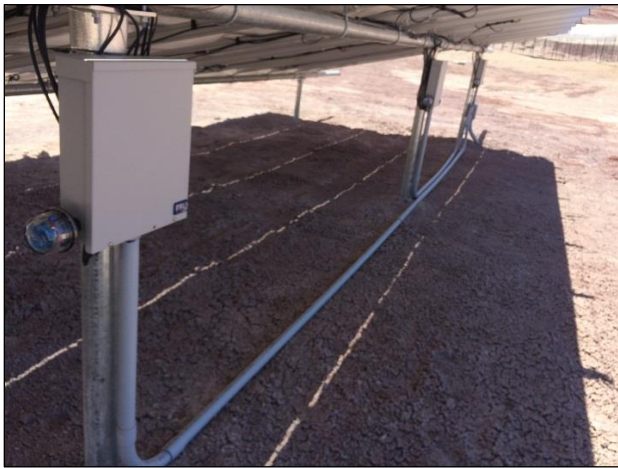
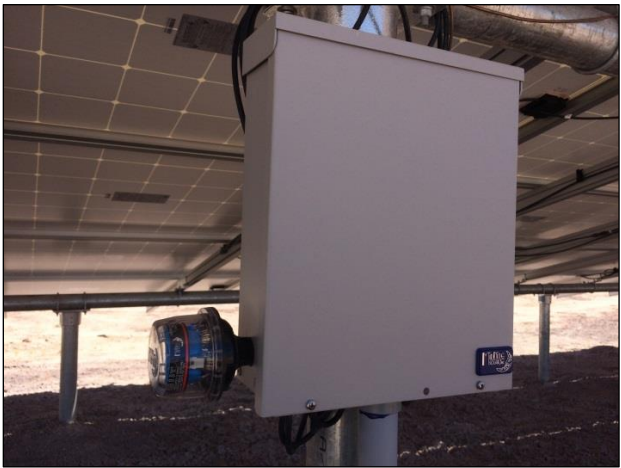
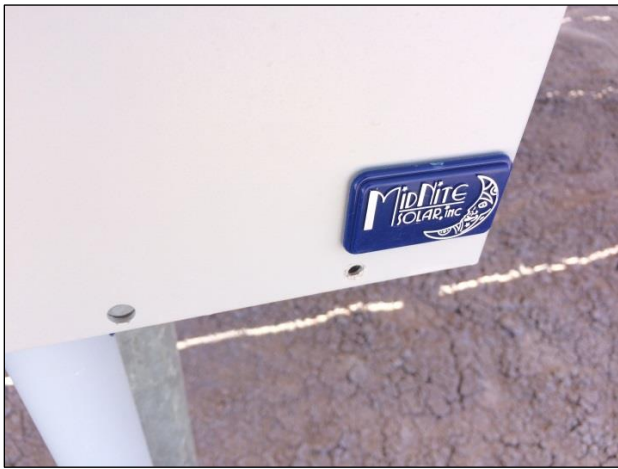
### Solar Array

This is a sizeable solar array! There are a total of 45 individual panels. The solar cells on each panel measure ~37.5" x 75", or 3.125' x 6.25' = ~19.5 sq ft ea. The total area of solar cells is therefore ~878 sq ft. I captured a picture of the label on the underside of one of the panels. It indicates a maximum power production per panel of 335W. With 45 panels, this is a max power output from this array of 15,075 W (15kW).

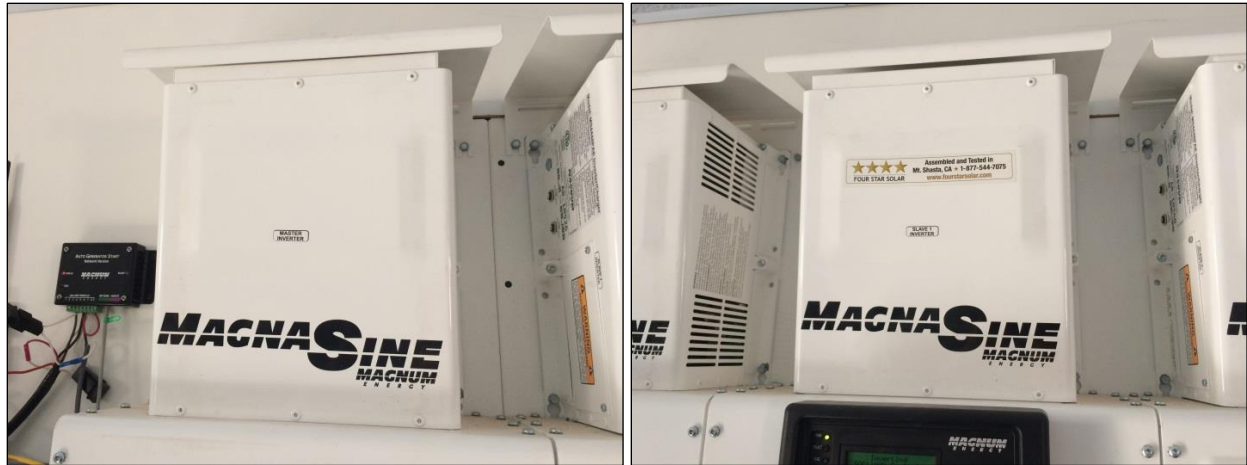
Inside the Science Dome, a good section of the wall on one side is taken up by electrical conditioning equipment and batteries which are stored in three large boxes on the floor.

There are three white boxes labeled “MagnaSine Magnum Energy”. The first is labeled “Master Inverter”. The others are labeled “Slave 1 Inverter” and “Slave 2 Inverter”. I am not sure of the precise configuration or why there is a Master, Slave 1 and Slave 2, but these are clearly the invertors that take DC put out by the solar panels and stored in the batteries and convert it to AC.

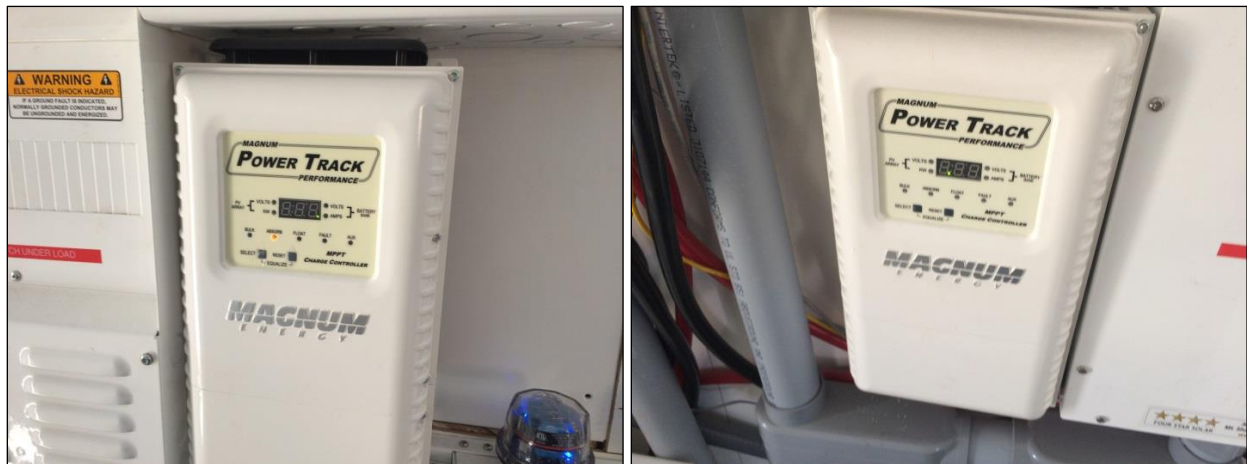
There were breakers that indicated they would be used for Inverter AC Bypass, Inverter AC Output, Inverter AC Input, Inverter DC Disconnect, C.C. #1 PV Array Input and C.C. #1 PV MPPT Output.

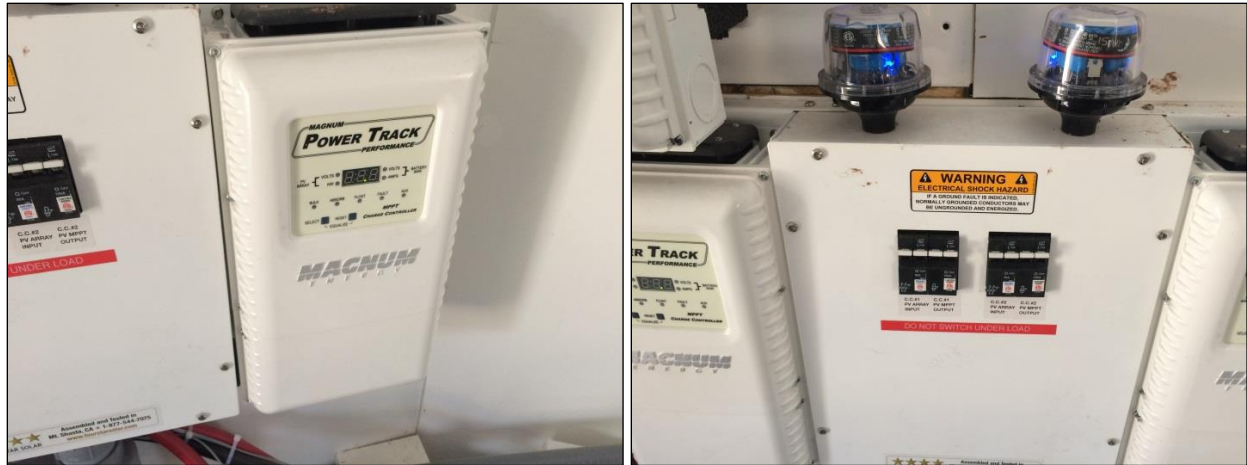
There were three white Magnum energy boxes labeled “Power Track Performance” and “MPPT Charge Controller”. MPPT stands for “Maximum Power Point Tracker”. These are DC to DC converters that match the output voltage of the PV array to the optimal voltage needed to charge the batteries.

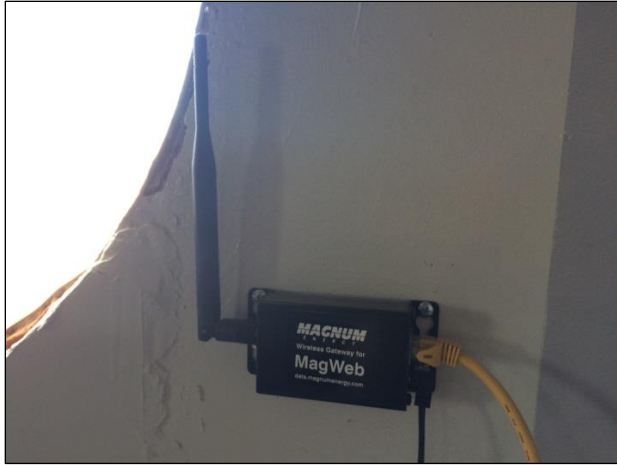
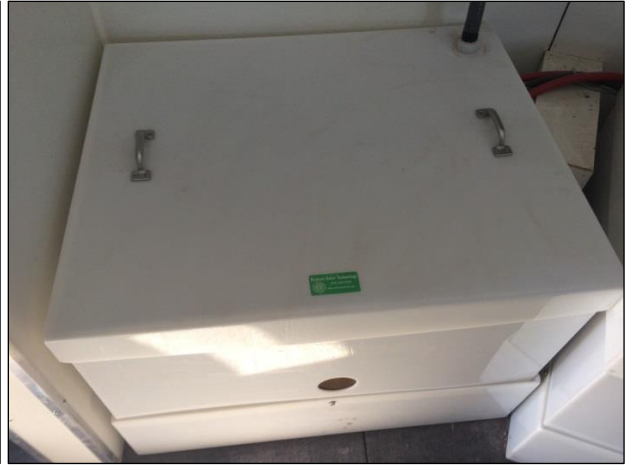
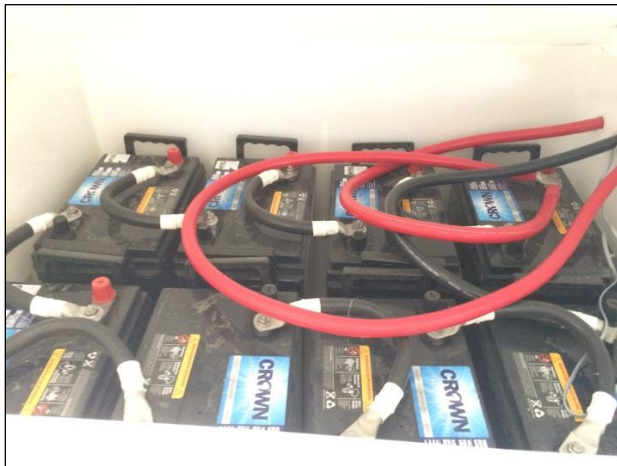
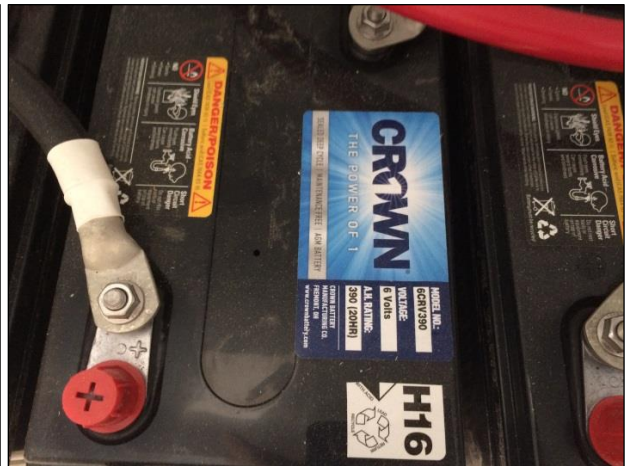
There was a traditional electrical distribution box with breakers labeled “Main” and “Dome Outlets”. There was also a box labeled “Auto Generator Start, Network Version” and another box with an RF antenna labeled “MagWeb”. The first box I believe is intended to start and stop the generator as needed depending upon the available power from the array and the state of charge of the batteries. The second box I believe communicates with a similar MagWeb box which is located in the hab and which is connected to the main wifi router, allowing you to interface with the system through a web-based application.

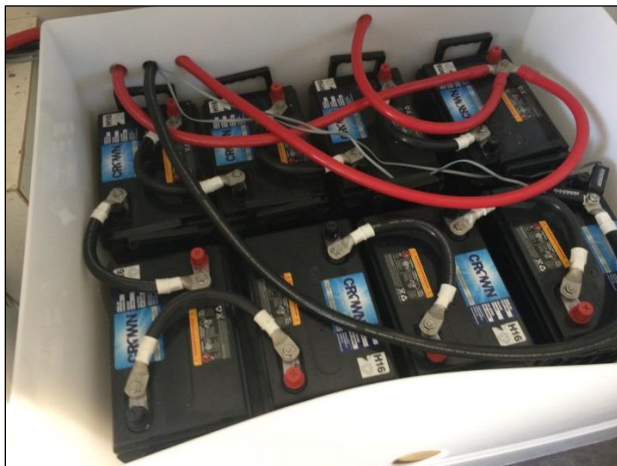
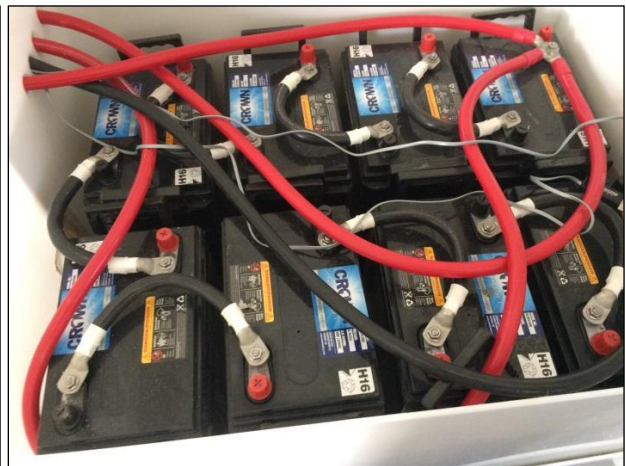
Finally there are the three battery storage boxes. Each box contains 8 batteries, for 24 batteries total. The batteries are labeled “Sealed Deep Cycle, Maintenance Free, AGM Battery”. They are Crown 1 model number 6CRV390, 6 volts, 390 (20HR) A.H. Rating.

Each of the batteries is rated at 390AH. With 24 batteries, this is a total of 9,360 AH. Multiplying by 6V, we obtain 56,160 WH.

I know that we operated FMARS on a power budget (from the generator) of ~5kW continuously. If we were to divide the 56,160 WH by 5,000 W, we arrive at 11.2 hrs. This would seem to imply that this battery bank could provide the same energy as a 5kW generator running all night.

The problem is that we cannot completely discharge these batteries. In fact, the manufacturer recommends we only drain the batteries to a depth of discharge of 75% maximum (meaning 25% of the energy stored in the batteries is still in the batteries and we have only discharged 75% of the stored energy). So only 75% of the 56,160 WH is really available to us. This is 42,120 WH.

If we assume ~10 hours of darkness each night, this means that we can draw a maximum of 4,212 W continuously during this timeframe.

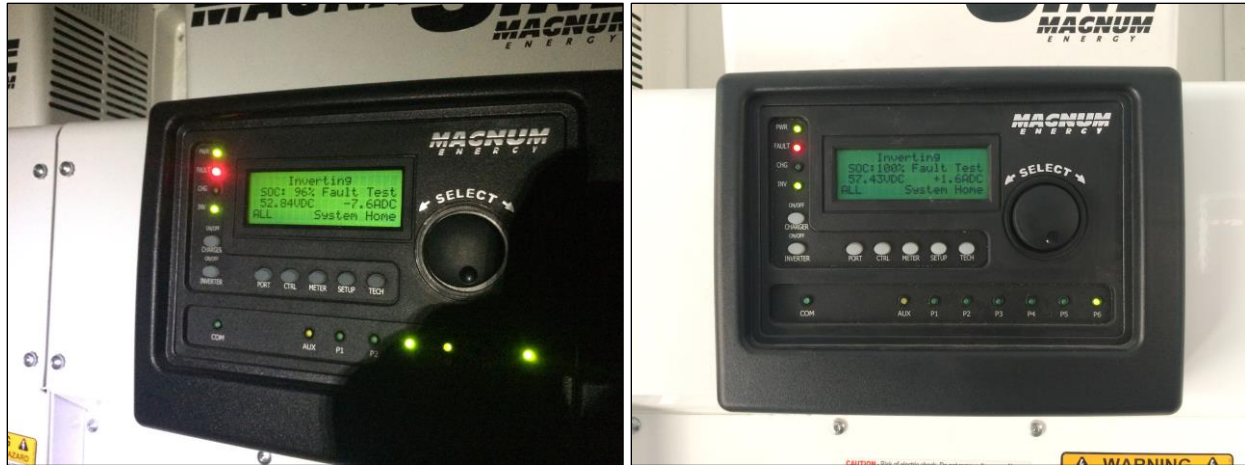
The master controller was observed several hours after sunset and a picture taken of the display. We can compare this photo (on the left) with the photo taken of the display during the day (on the right). As we can see, the state of charge has decreased from 100% to 96%. This was due to this engineer running some lights and other loads for several hours, drawing from the batteries. We can also observe that the current indicated has changed from +1.6 ADC during the day to -7.6 ADC at night. One can surmise that this shows that the batteries were being trickle charged using 1.6A during the day and that they were being discharged at night at a rate of 7.6A (with only a minimal number of loads running).

A complete assessment of the various electrical loads in use at MDRS should be performed, with a specific eye to those loads that need to be run at night. Most likely the largest load would be air conditioning (when needed). This assessment will identify the typical discharge rate of the batteries and determine if the current capacity is sufficient, or if it would be prudent to add additional batteries.
